An Overview of Failure Analysis of Tantalum Capacitors

Javaid Qazi, Kemet Electronics

Tantalum Capacitor FA

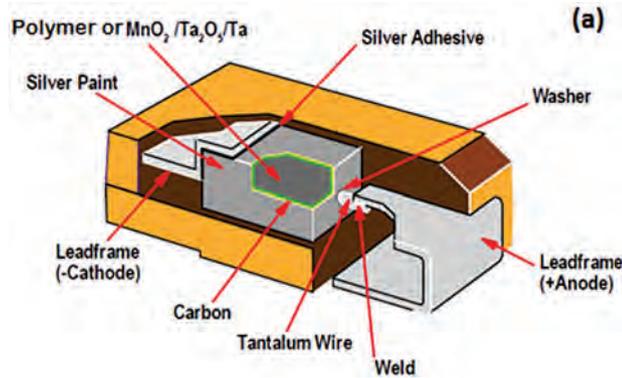
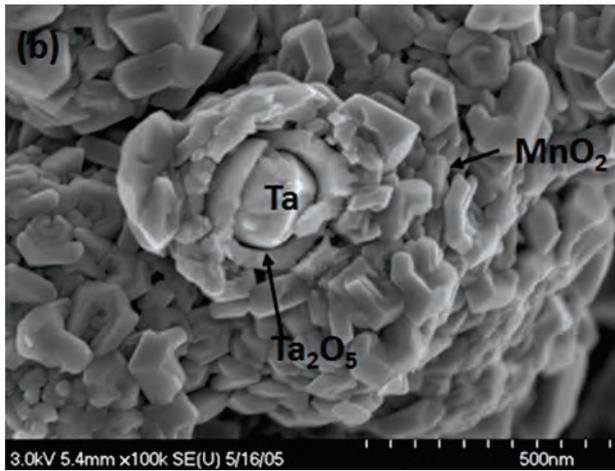
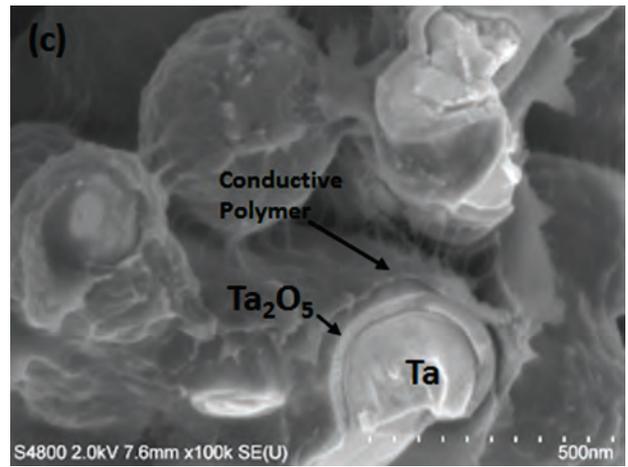
Fig. 1 (a) Typical construction of a tantalum CAP. The tantalum/dielectric/counter-electrode inside the tantalum anode is shown (b) for MnO_2 and (c) for a conductive polymer tantalum CAP. Source: Ref 1

Miniaturization of electronic devices demands higher and higher capacitance in a smaller volume. One way to achieve higher capacitance in a small volume is to increase the “ A ” in Eq 1. This is achieved differently in different types of capacitors. In the case of tantalum CAPs, for example, it is achieved with porous tantalum anodes (high surface area/volume), which are produced by pressing and sintering tan-

talum powder, with an attached tantalum wire. An amorphous Ta_2O_5 dielectric is then electrochemically grown on this high-surface-area porous tantalum anode. The Ta_2O_5 is typically a few tens of nanometers thick. The porous anode is then impregnated with a counterelectrode layer (MnO_2 or conductive polymer), providing high capacitance in a small volume (Fig. 1). Solid-state tantalum capacitors are typically used for 100 V or below, with most of them being 50 V or lower. Wet tantalum capacitors (the counterelectrode being a liquid) allow higher working voltages, up to a few hundred volts.

Because of significant dissimilarity in the materials and construction of different types of CAPs (Table 1, Fig. 1 and 2), the cause of their failure is also

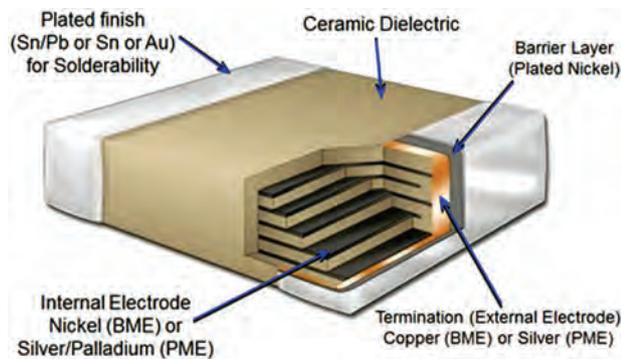
Fig. 2 Typical construction of a ceramic capacitor. BME, base metal electrode; PME, precious metal electrode. Source: Ref 1

In film and ceramic CAPs, thin layers of dielectric and electrode materials are stacked alternately, with alternating electrodes displaced to avoid contact between the opposing terminals. Figure 2 shows the typical construction of a ceramic capacitor. A few tens to hundreds (in ceramic CAPs) or even thousands (in film CAPs) of these layers can be stacked to obtain the desired capacitance.

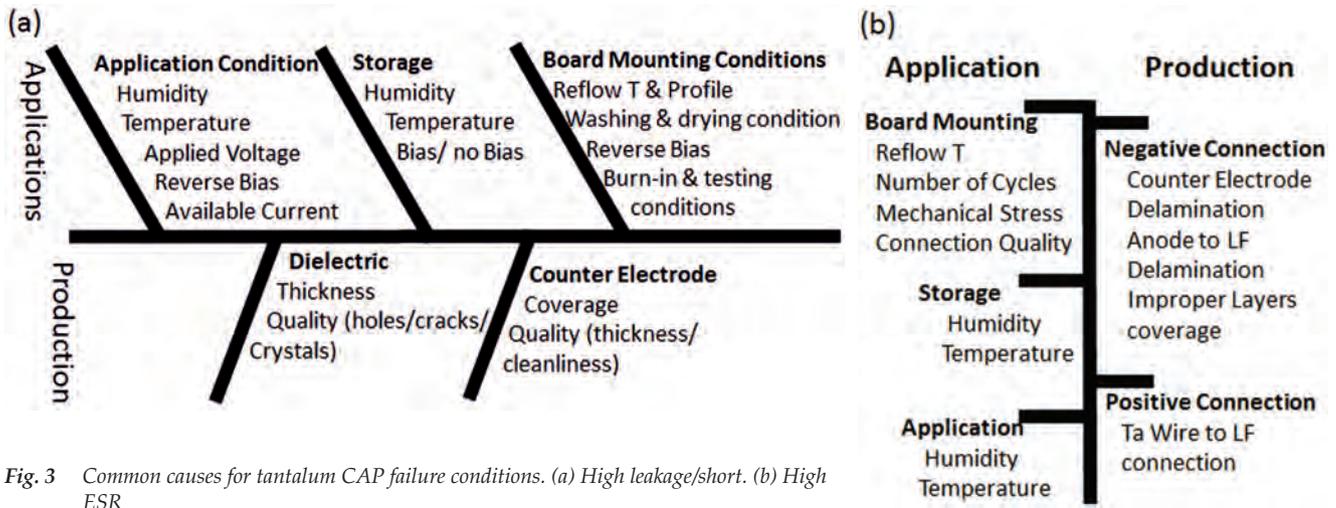
Fig. 3 Common causes for tantalum CAP failure conditions. (a) High leakage/short. (b) High ESR

the CAP was exposed to, such as board mounting, storage, application parameters, environmental conditions, time to failure, and so on, should be collected and analyzed as well, because FA of the failed CAP alone may not provide the root cause. Figure 3 lists the most common causes (divided into application and production) that can contribute to a tantalum CAP failure. It is worth noting that failed capacitors resulting from application conditions or production anomalies may be very similar.

If the CAP has a DCR less than ∞ , then there is a conductive path between its positive and negative terminals. Assuming that the CAP has been isolated from the circuit, either the leakage path is through the tantalum anode (the dielectric has been compromised) or a conductive path has been formed between the positive and negative terminals, bypassing the tantalum anode. The CAP should be examined to ensure that no bridging is present externally. There could be a number of reasons that lead to either possibility, as shown in Fig. 3(a), which can be broadly divided into application or production.

Tantalum CAPs, like any other electronic component, could also fail due to their application conditions (Fig. 3a). As a polar device, the tantalum CAP can withstand a small amount of reverse bias for a short period of time; however, it is not very forgiving when subjected to reverse polarity. If a CAP is suspected to have experienced reverse bias, it may be possible in

The cause of high ESR can be divided into two main categories: a loose connection or an increase in the resistivity of the material (Fig. 3b). Again, before performing any destructive analysis, the high-ESR condition must be verified at the appropriate frequency, and, more importantly, proper connections between the testing probes and the CAP terminals must be ensured. The presence of any conformal coating or flux on the solder joint, improper solder/adhesive joints, oxidation of the terminals/solder joint, inappropriate probes, and so on could falsely show a higher ESR than the actual value.

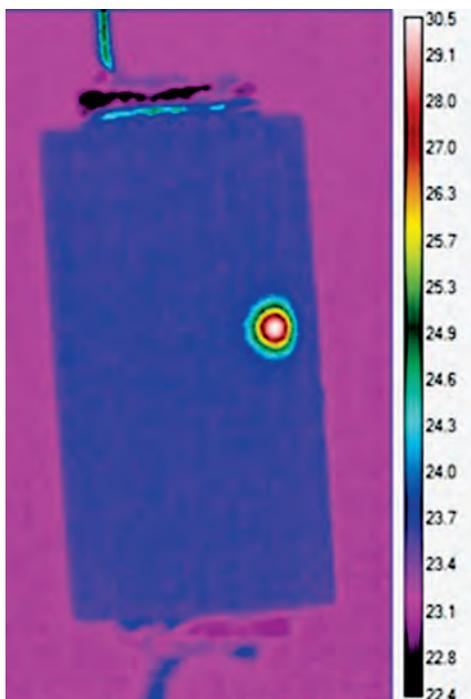
Fig. 4 Thermal image of a tantalum CAP shows a hot spot indicative of a fault site.

Knowing the location of the fault site inside the CAP before performing any destructive analysis is very valuable, especially for large case sizes and multiple-anode CAPs. Figure 4 shows the thermal image of a high-leakage CAP subjected to the rated voltage and a very small amount of current applied for a very short period of time. Localized internal heating at the fault site results in a slight increase in localized temperature, which is recorded by the thermal imaging system. Thermal imaging in combination with x-ray analysis allows pinpointing of the fault location. This approach increases the FA success rate and reduces FA time. The CAP can then be cross sectioned to the fault site, and the anode and the counterelectrode layers can be analyzed for any anomalies. If the CAP has no physical anomaly, its DCR is in the hundreds

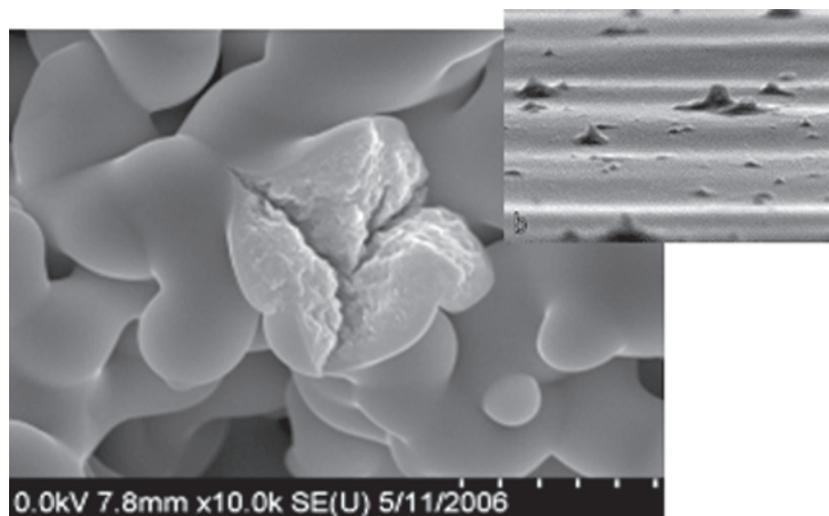
Fig. 5 Crystals on tantalum anodes. Source: Ref 6

Based on the failure mode, the tantalum CAP could be chemically stripped to examine the tantalum anode's integrity and the dielectric quality.^[5] Tantalum dielectric is typically electrochemically grown at two to three times the CAP's rated voltage to provide a more robust dielectric. Flaws in the dielectric, such as a crystalline oxide (Fig. 5), could be examined by stripping away the counterelectrode layers. Crystalline oxide nodules weaken the amorphous dielectric and provide a conductive path. The presence of a few of these sites could be isolated by the healing mechanism of the tantalum CAP. With everything else being the same, crystalline oxide is more pronounced for high-voltage CAPs (typically 35 V and higher), and the presence of a significant number of these sites could be a problem. Over the years, many processes have been developed to minimize/eliminate crystalline oxide growth.^[6,7]
