### **Stress Reduction Improves the Thermal Robustness of KEMET Ceramic Chips**

*by Andy Henderson*

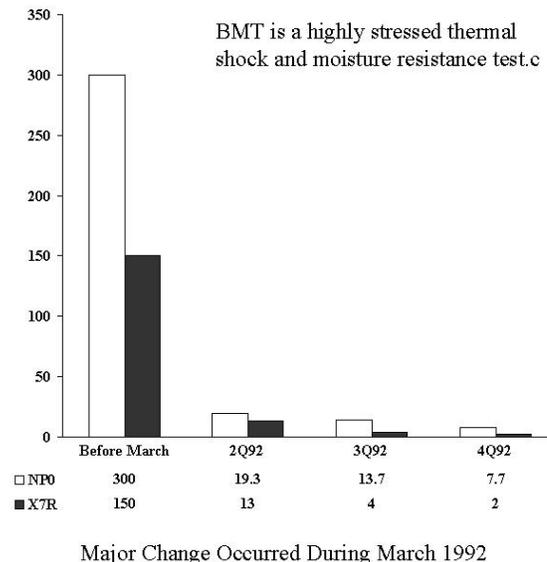
**Figure 1.**  
**Involvement in BMT Stress Failures**  
**Resulting from Process Changes**

The new end termination firing process resulted in an immediate 90% improvement in the rate of stress-related BMT failures in production chips. The identification of other critical variables resulted in two more significant process changes, implemented in the fall of 1992, that brought the total improvement to 97% as of November 1992 (see Figure 1). Customer feedback has also shown a significant decline in thermal stress-related failures in the field.
