# Effects of Lead-Free Solders on Flex Performance

KEMET Electronics Corp.

This paper was written in response to customer concerns of flex performance as they switch from lead based to lead free soldering processes. In this paper we present the results of flex testing, comparing standard lead based solders to lead free solders.

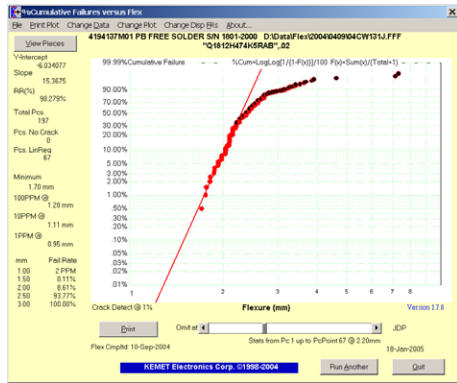
## 1812C474K5RAB – Pb-Free Solder

Figure 2 shows the Weibull plot of cumulative failures for an 1812 capacitor mounted with a Pb-Free solder. The calculated failure rate line is generated using the lower end of the Weibull distribution. This line is used to predict the expected failure rate at a given displacement.

**Figure 2. Weibull plot of 1812, .47 uF, X7R**

The calculated failure rate line is also used to calculate the amount of flex required for 1 PPM, 10 PPM, and 100 PPM failure rates.

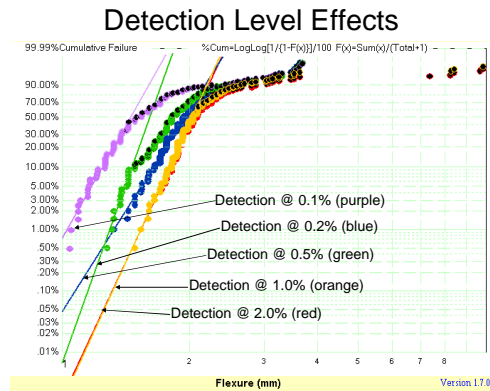
Because continuous data for each part is stored, there is the ability to review post test data to investigate different crack detection limits. Figure 3 shows the Weibull distribution of a single test. The analysis was performed at several different detection levels. There is little difference between 2.0% and 1.0% levels, but when .1% and .2% levels are analyzed, random noise in the measurement gives a false indication that a crack has occurred. Selecting the appropriate crack detection limit is important. If a chip with 10 layers is flexed and a crack occurs across a single layer will result in a capacitance loss of 10%. Likewise, a crack across a single layer of a capacitor with 100 layers will result in 1% loss in capacitance. And a capacitor with 500 layers or more, a crack through a single layer will result in less than .2% loss in capacitance. It is important to evaluate the design and data to determine the appropriate detection limit. After reviewing all the data, it was determined that a 1% detection limit was acceptable for all but 0603 case size for this study.

**Figure 3. Different detection levels for the same part number**

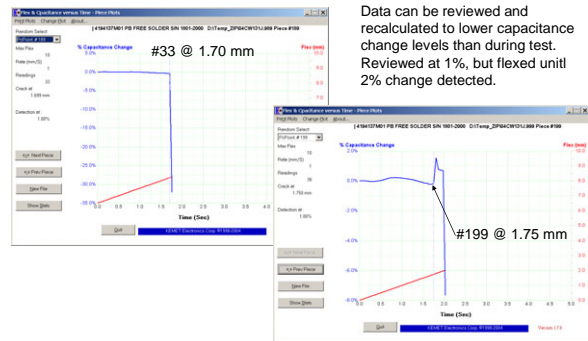
### Two Lowest Readings

Figure 4 shows the capacitance versus millimeters of flexure for the two lowest readings for the C1812C474K5RAB part number. Because of the piezoelectric effect inherent in high K dielectrics like X7R, Capacitance will decrease as physical stress is generated across the capacitor. The crack signature for piece #199 (on the right) shows that the capacitance actually increases when the crack occurs. This is the result of the flex crack only occurring in the margin area or in the solder fillet, but not in the active layers of the capacitors. The crack through the margin areas relieves the stress generate by the flexure, and capacitance is regained. It is also interesting to note that the original 2% limit did not detect the correct limit. With this 2% limit the flex crack was detected at somewhere around 2 mm, but on further investigation, the initial crack occurred at 1.75 mm as the mechanical stress is relieved.

**Figure 4. Actual data for the two lowest readings.**

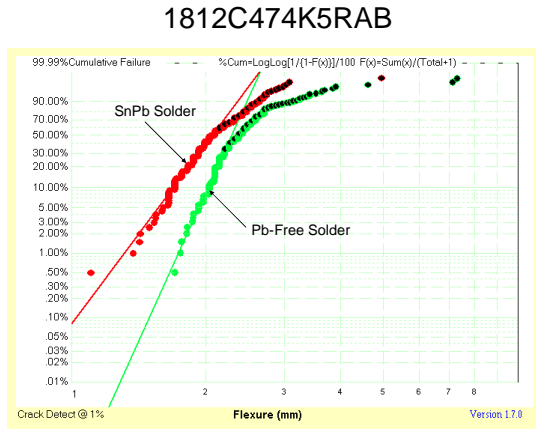
It is commonly believed that because the Pb-Free solders are less ductile<sup>[2]</sup> and therefore would be less likely to absorb the forces generated, causing a larger failure rate for a given flex amount. If the two Weibull plots are overlaid the comparison becomes much easier. For the 1812 .47 uF, X5R (Figure 5), it is apparent that the Pb-Free solder had better flex performance. This contrasts common belief that Pb-Free solders would cause an increased failure rate at a given displacement.

**Figure 5. Flex performance 1812, .47 uF X7R, Pb-Free vs. SnPb Solders**

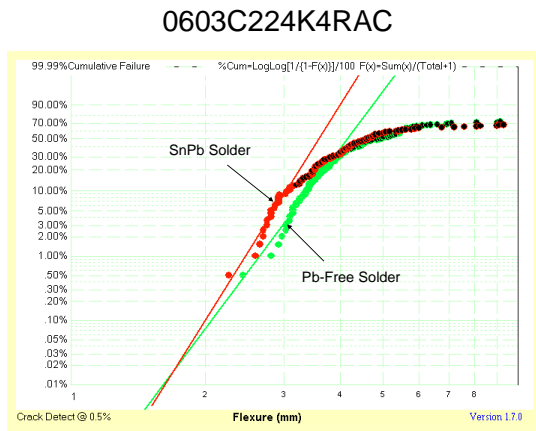
When the two Weibull plots for the 0603, .22, X7R plots (Figure 6) are overlaid, shows that there is almost an equal performance between Pb-Free and SnPb solders. Since this is a high capacitance part number with many layers, the crack detection limit was set to .5%.

**Figure 6. Flex performance 0603, .22 uF X7R, Pb-Free vs. SnPb Solders**

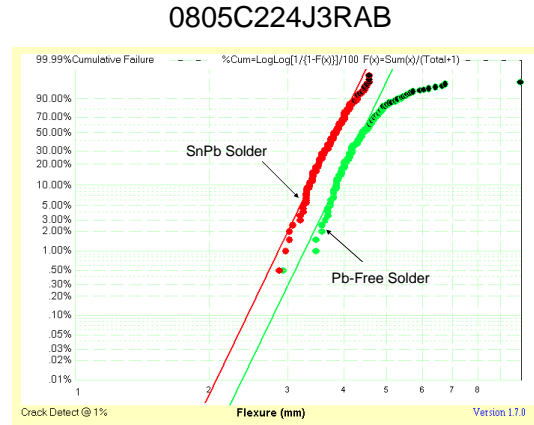
Figure 7 shows the performance of an 0805, .22 uF X7R part. Although the Pb-Free parts performed better, the difference between the two plots at the calculated 100 ppm failure rate is less than .3 mm of flexure.

**Figure 7. Flex performance 0805, .22 uF X7R, Pb-Free vs. SnPb Solders**

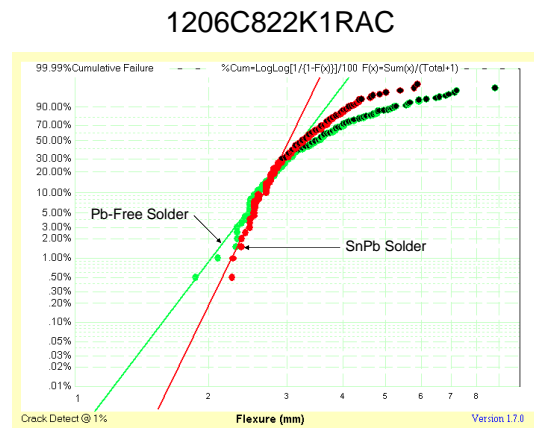
The low capacitance 1206, 8.2 nF, X7R in Figure 8 shows an interesting result that for lower stress levels, the SnPb solders performed better. Because of the lower shallower slope of the Pb-Free line, above 2.6 mm of flexure stress, the Pb-Free soldered parts performed better.

**Figure 8. Flex performance 1206, 8.2 nF X7R, Pb-Free vs. SnPb Solders**

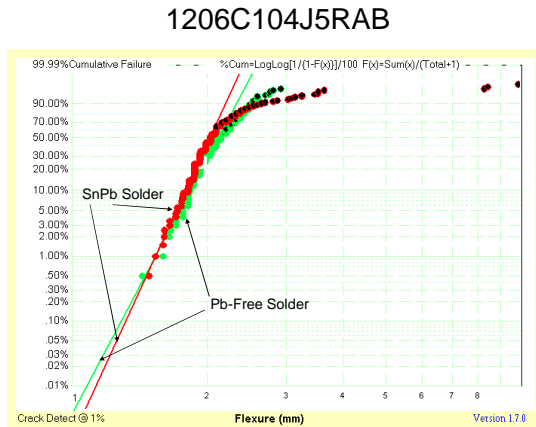
The high capacitance 1206, .1 uF, X7R (Figure 9) showed that both performed equally well, with no discernable difference in flex performance.

Figure 9. Flex performance 1206, .1 uF X7R, Pb-Free vs. SnPb Solders
